Technical Report on Corrosion of Aluminum Windows

Technical Report on Corrosion of Aluminium Windows

May 2025

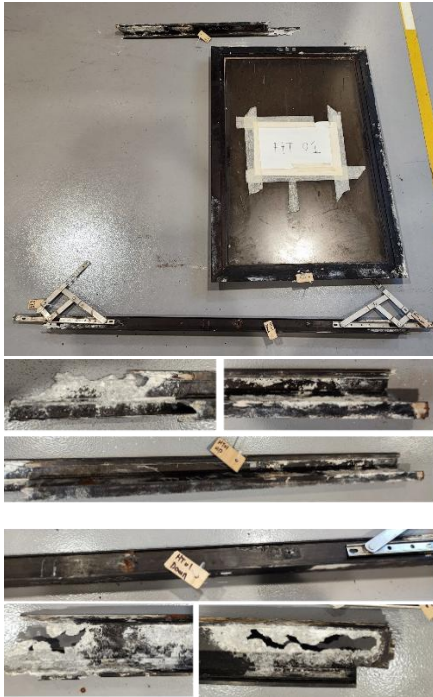
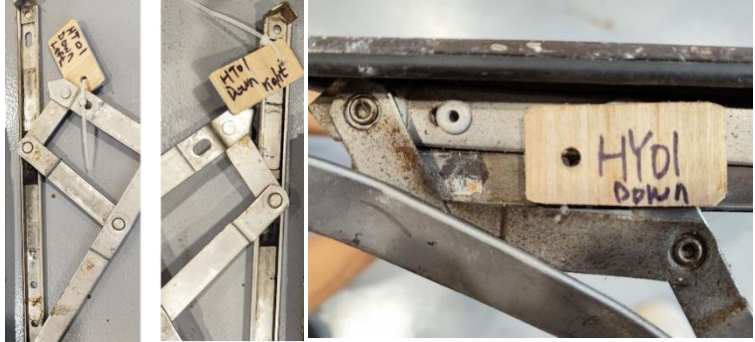
Window HT01

For sample HT01, the analysis of the greyish powder identified both aluminium hydroxide and sodium chloride. The presence of aluminium hydroxide suggested the corrosion of window frame/rivet. However, the origin of the salt remains uncertain, as the building was located 1 km away from the sea, making it unlikely that the salt originated from the seaside. Brown rust is present for HT01, the chemical analysis identified the presence of iron oxide hydroxide (FeOOH). Given that the hinge remains in good condition, it was believed that the rust was produced by corrosion of other component such as screws.

(a) Frames

(b) Hinges

Corrosion Research Window Samples				
No.	District	Building Age	Approx. Distance from sea (m)	Defects found
HT01	Western	32	100	• Moderate to serious corrosion of rivets
HY01	Eastern	36	1,500	• Moderate to serious corrosion of rivets
HY02	Southern	33	<100	• Moderate to serious corrosion of rivets
HY03	Southern	33	<100	• Moderate corrosion of rivets
HT04	Yau Ma Tei	49	1,000	• Moderate to serious corrosion of rivets
HT05	Yau Ma Tei	49	1,000	
HT06	Yau Ma Tei	49	1,000	• Moderate corrosion of rivets
HT07	Yau Ma Tei	49	1,000

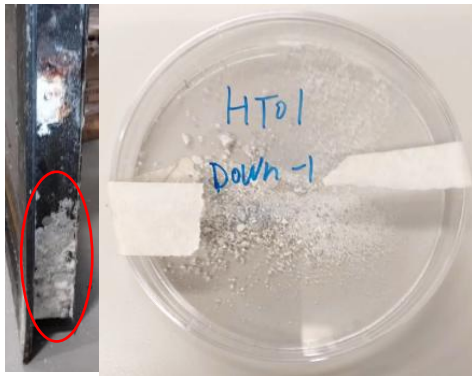
(c) Rivets and screws

(d) Greyish powder

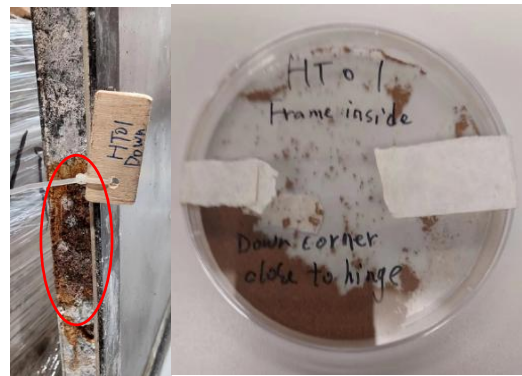
(e) Brown rusts
